Who Designed the Ill-Fated St. Francis Dam?

J. David Rogers, Ph.D., P.E., P.G., F.ASCE¹

Abstract

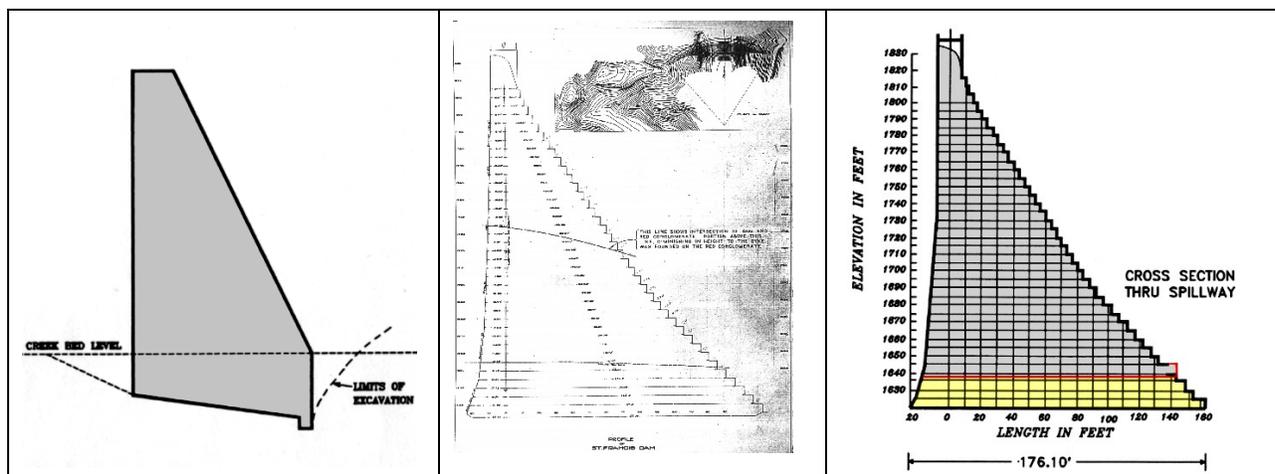
Figure 1. Left pane shows the original maximum section through the St Francis Dam, made in July 1923. Middle pane shows the as-built drawing released by BWWS after the failure, showing a flared toe, up to 175 ft wide at elevation 1625. The right pane shows the actual limits of the dam in red, with a base width of 148 ft.

The dam was subsequently raised 20 vertical feet, about 11% of its original height (175 ft) without any corresponding adjustment of the dam's base width. The elevation of the stream bed was about 1655 ft, and the maximum depth of excavation was about 16 ft, to an elevation of

1639 ft. The last step is clearly observed in construction photos at the time (Outland, 1977), five feet below Outlet No. 1, at an elevation of 1645 ft. The cross section presented by BWWS to all of the investigative panels after the failure was not an accurate portrayal of the dam's maximum section, especially with regards to estimating the factor of safety with regards to cantilever overturning (even ignoring uplift).

These discrepancies resulted in erroneous evaluations of the dam's static stability by most of the investigative panels in 1928 (Rogers, 1992; 1995). Rogers and McMahon (1993) showed that the dam's maximum section became unstable in cantilever overturning when the reservoir rose to elevation 1830 ft, seven feet below the spillway sill. Although ignored in the original design, the arch stresses began exceeding 7000 pounds per square foot (psf) at elevation 1822 ft, increasing to 10,000 psf at elevation 1830, five feet below spillway crest. The reservoir had been brought up to within 4 ft of the spillway for 17 days in mid-May 1927, but was not filled to capacity until March 2, 1928, 10 days prior to the failure (Fig. 2).

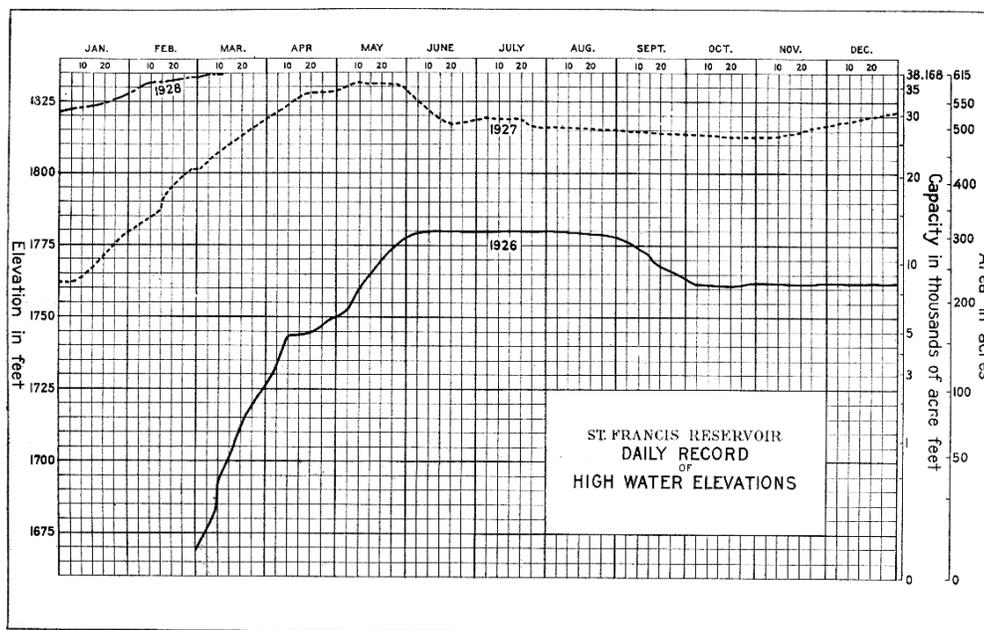
Figure 2. Daily record of reservoir elevations between March 1, 1926 and March 13, 1928. Note the reservoir was not filled to capacity until March 2, 1928, 10 days before the failure (Committee Report for the State, 1928).

The dam collapsed 10 days after the reservoir's initial filling, to within three inches of the spillway sill. This condition would have represented the maximum pore water pressure being applied to the dam mass and its foundations.

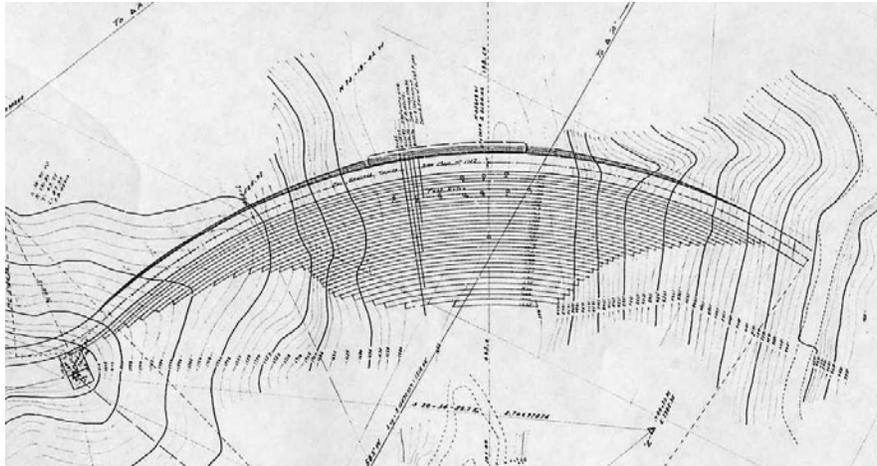
Records preserved in the LADWP Archives suggest that 10 shallow borings were made in the channel of San Francisquito Creek to probe the depth of the channel gravels (Fig. 3). These were drilled in two parallel lines, along the dam's axis, three being 4 m deep and the remaining seven being 8 m deep. These are the same holes utilized as uplift relief wells beneath the upstream third of the main dam. The sloping abutments and wing dike were not explored by anything more than open trenches at the time of construction and were bereft of any uplift relief.

Figure 3. Plan of the dam dated November 1924, with the locations of the 10 test holes that were converted to uplift relief wells, split into rows of three shallow and seven deeper holes (LADWP).

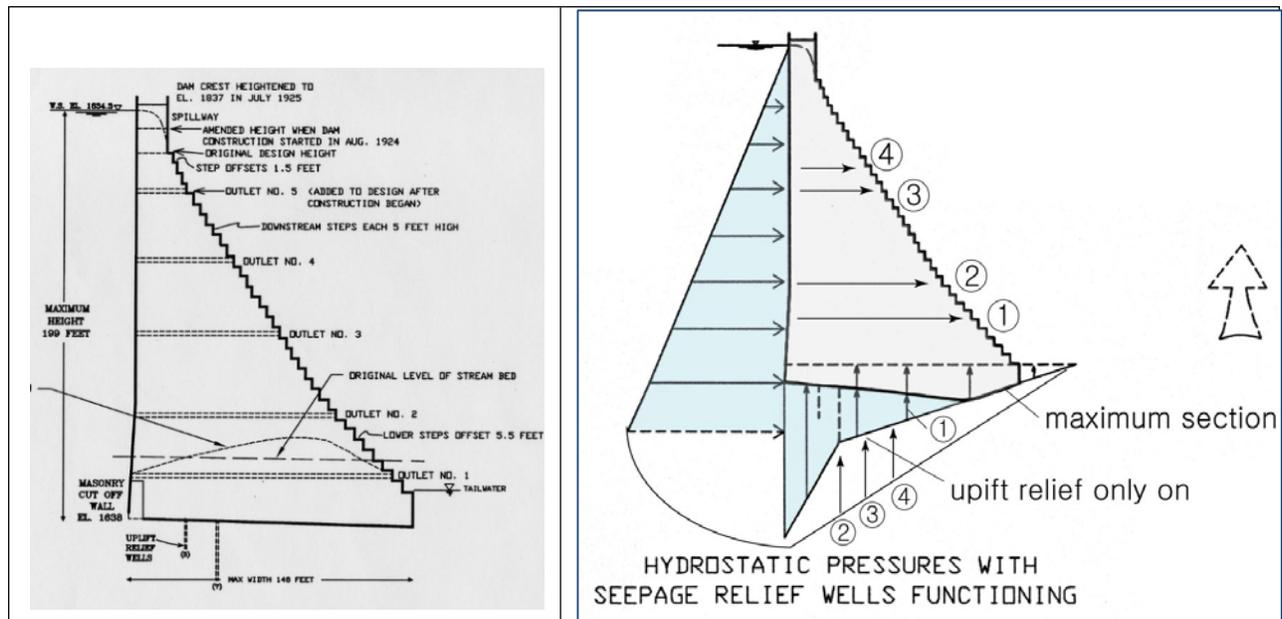
side of the central section of the dam,” but Hurlbut’s answers suggest BWWS ignored the issue of uplift relief on the steeply sloping abutments. It was the two sloping abutments of the dam that failed catastrophically, not the main section. The enormity of this problem was not revisited in any significant detail until the untimely failure of the Malpasset arch dam in 1959.

Figure 4. Left pane is a maximum cross section through the dam showing the locations of the 10 uplift relief wells beneath the upstream third (Rogers, 1995). Right pane shows the likely impact of uplift relief beneath the dam’s main section, prior to caulking of the transverse shrinkage cracks in early 1928.

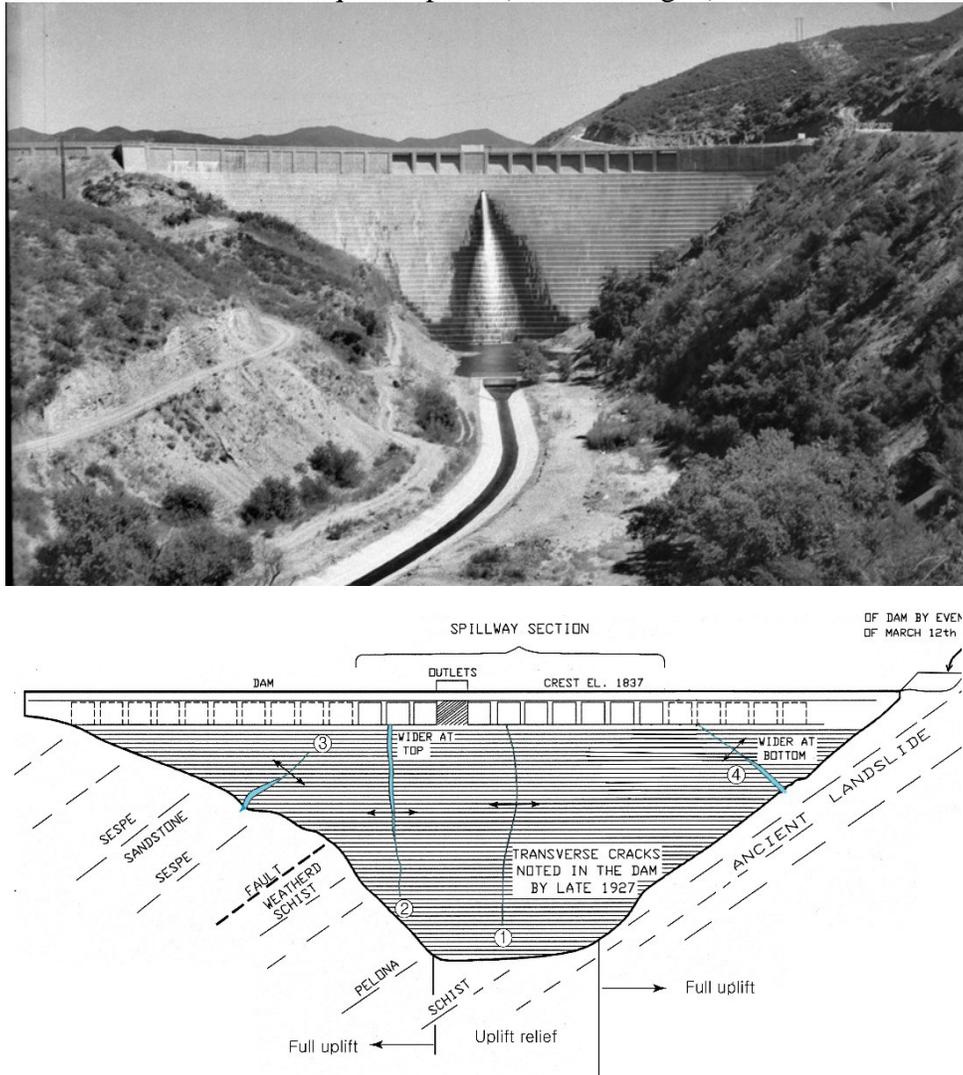
Significant shrinkage cracks developed in the St. Francis Dam as the mass concrete cured (BWWS employed a 4-sacks of cement per cubic yard mixture, the same as the US Bureau of Reclamation). BWWS Chief Surveyor James E. Phillips testified that “*the first prominent shrinkage crack was about 75 to 100 feet east of the right abutment thrust block.*” Another crack

developed “58 to 60 feet west of the gates” [outlet pipes], and another crack approximately the same distance on the other side, and one at about the “quarter point” of the main dam. Another transverse crack formed at the other quarter point (shown in Fig. 5).

Figure 5. Stepped downstream face of the St. Francis Dam, as viewed looking upstream. Four prominent shrinkage cracks developed, shown in the lower diagram. These were caulked with oakum on the downstream face and grouted in early 1928 (author’s collection).

Phillips stated that “*these cracks extended all of the way through the dam.*” He noted that the apertures of most of the shrinkage cracks were initially between $1/8^{\text{th}}$ and $3/16^{\text{th}}$ of an inch at the crest of the dam (Fig. 6). What engineers didn’t understand at the time was that the width was inconsequential; it was the transverse connectivity with the dam’s upstream face that impacted internal stability.

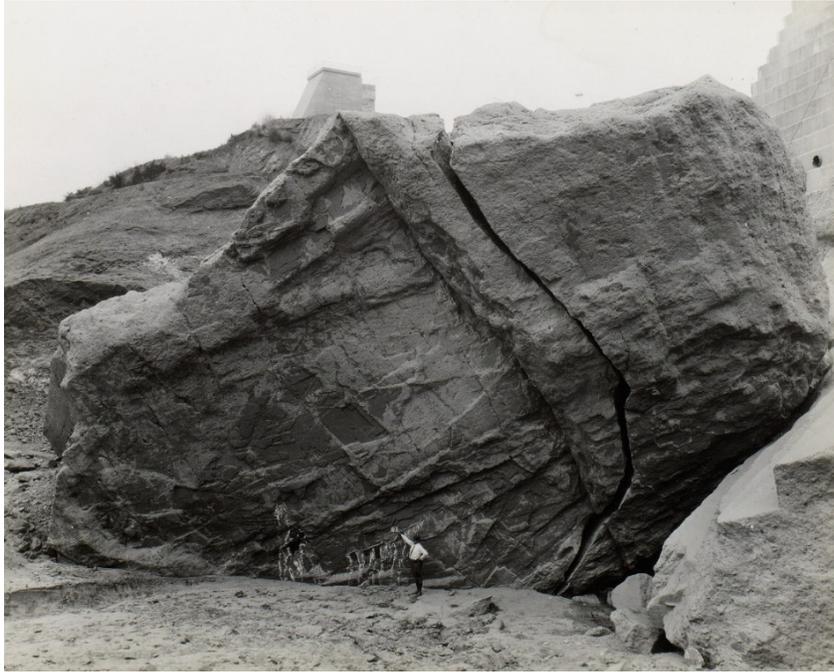
Figure 6. Upturned base of block #7, from the crest of the dam’s left abutment. The open fissure is transverse shrinkage crack #4, shown in the lower half of Figure 1 (Mayberry et al., 1928).

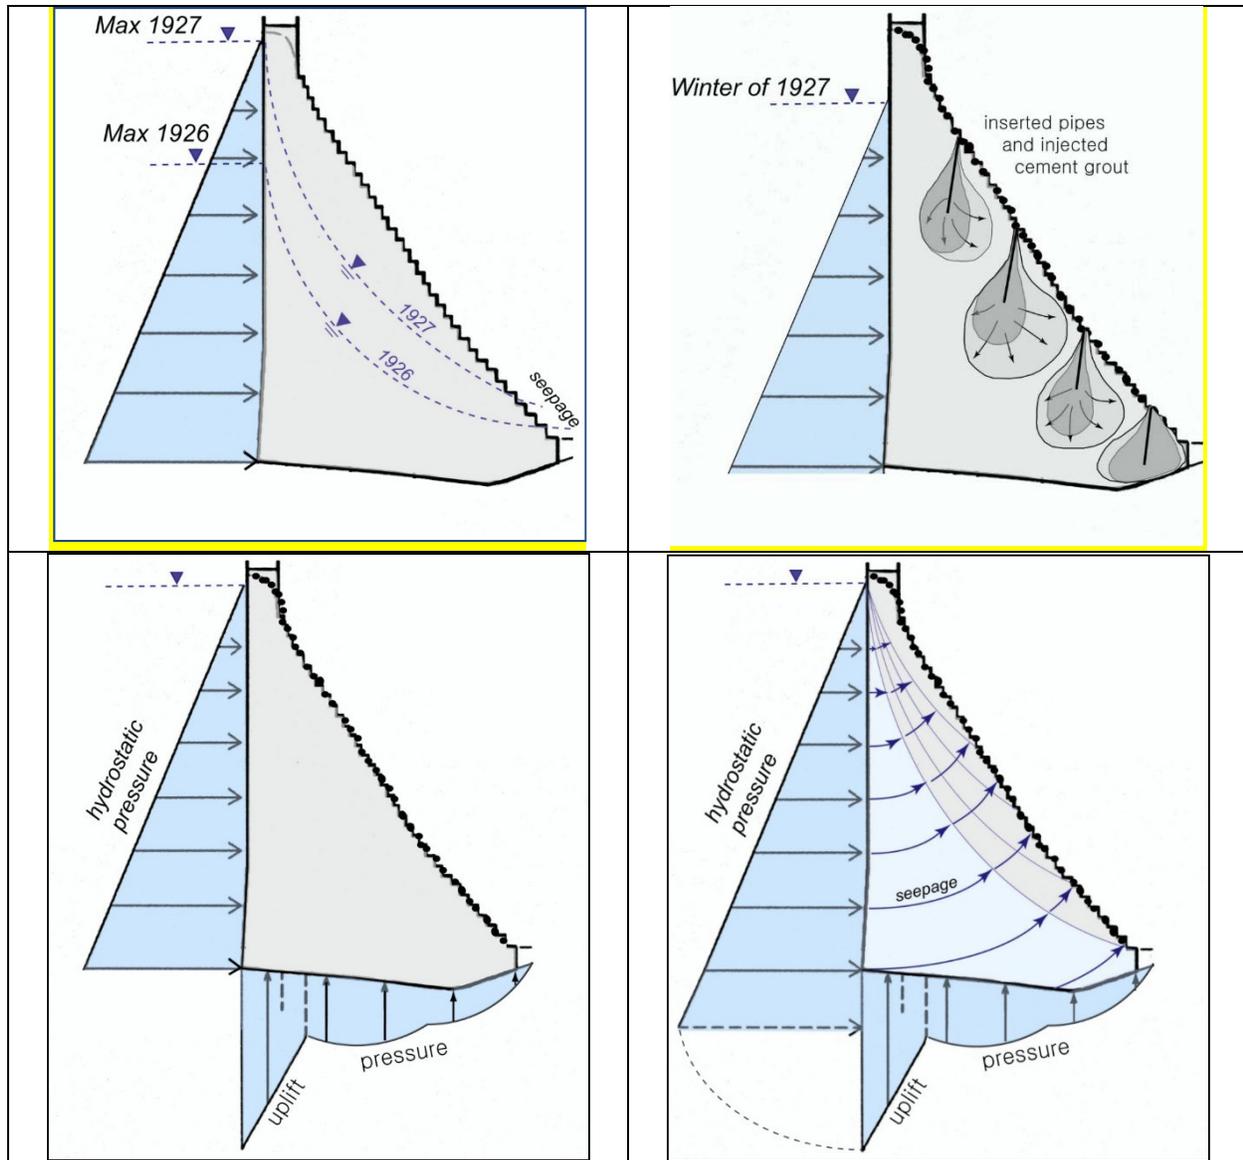
Phillips went on to describe how the shrinkage cracks were caulked with oakum; a mixture of hemp or jute fiber that was often smeared with tar, creosote, or asphalt to caulk seams in wooden ships and packing pipe joints. He noted that BWWS crews drilled holes into the dam

and “grouted the big cracks.” The oakum was placed on the downstream face of these cracks to keep the cement grout from “running out,” as sketched in Fig. 7.

Figure 7. Plugging of the dam’s contraction joints on the downstream face could have had disastrous consequences by creating full reservoir pressure against the interior faces of the main dam, especially if the grouting behind the face was anything less than a 100% seal. This was a detail apparently missed by all of the post-failure reviews in 1928.

William Mulholland's decision to caulk and grout the transverse shrinkage cracks in January and February 1928 (Fig. 7) likely triggered the dam's untimely demise a few weeks later. Mulholland's goal was to save precious water being lost through the cracks, but caulking the fissures with oakum on the downstream face served to trap reservoir water pressure within the dam itself, a potentially catastrophic situation because it would have hastened internal instability. This condition is born out to a noticeable degree in the downstream tilt of about one degree, recorded by the Steven's Gage on Block 1 of the dam, beginning around 8:30 PM on March 12th, 3-1/2 hours before the failure (Rogers 1995; 2007). Few people at the time understood the destabilizing impacts of pore water pressure beneath concrete arch dams, which were altered radically by the failure of Malpasset Dam in France in 1959.

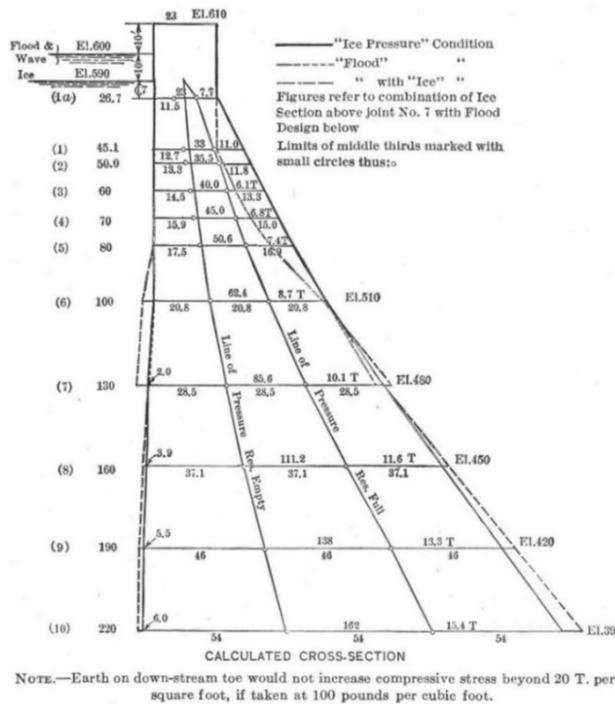
Figure 8. Example of the “stress diagrams” described by Edgar Bayley, taken from *Masonry Dam Design, 2nd Edition* by Morrison & Brodie (1916). This shows a maximum compressive stress of 20 tons per square foot (tsf) along the ‘Line of Pressure-Reservoir Full.’ These were the same values used by Bayley in the design of Hollywood Dam, which were then applied to St. Francis Dam.
