WHERE DAMAGE OCCURRED

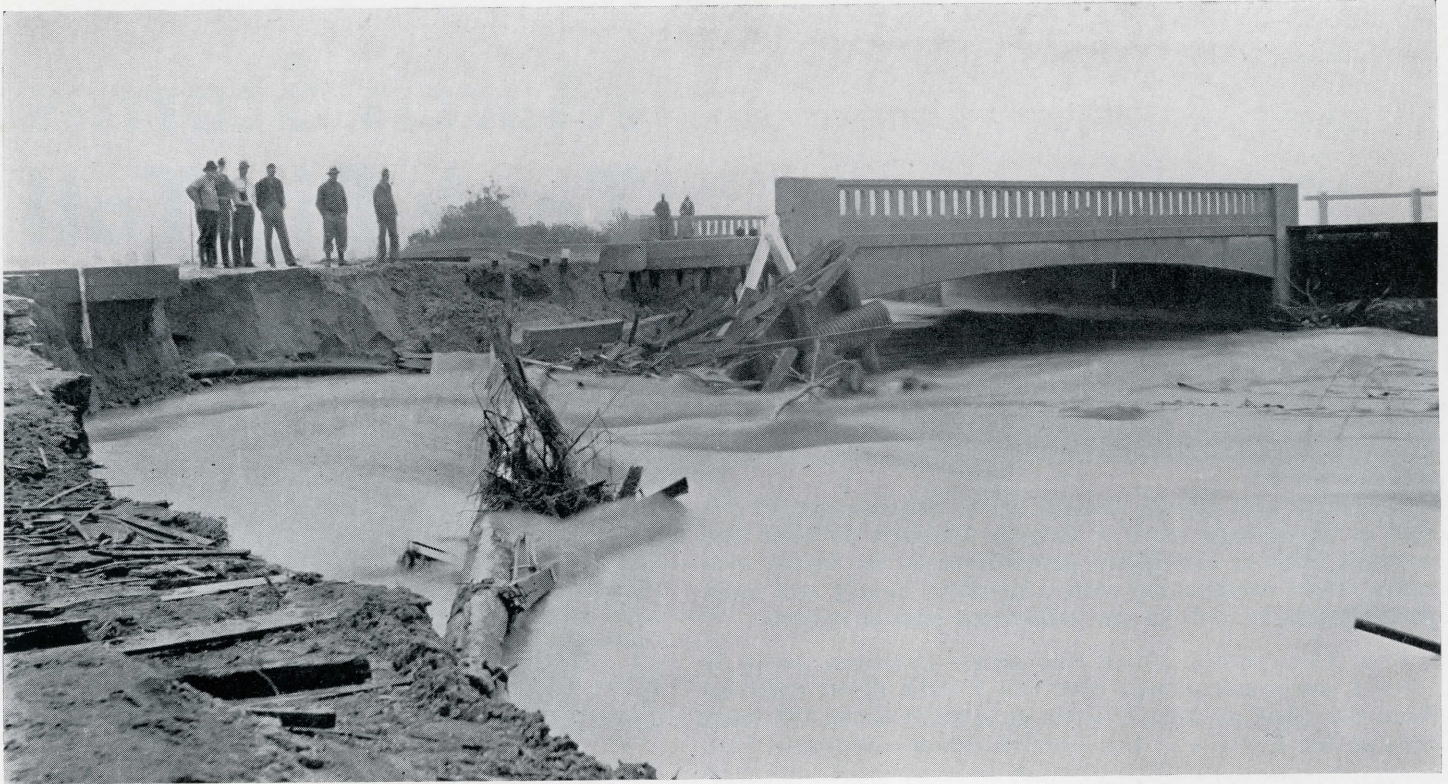
High waters in Barton Wash ripped away timber wing on this bridge on Route 168-C in Los Angeles County.
